WAD 2917 #75 11/4/1999

PORT OF SEATTLE/
BURLINGTON ENVIRONMENTAL, INC.
TERMINAL 91 FACILITY
SEATTLE, WASHINGTON

FINAL RESOURCE CONSERVATION AND RECOVERY ACT FACILITY ASSESSMENT

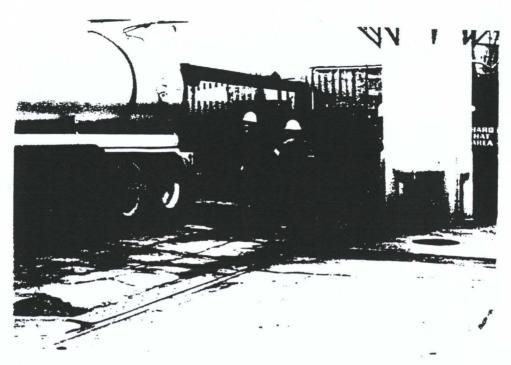
Photo 3. Oily wastewater truck off-loading area.

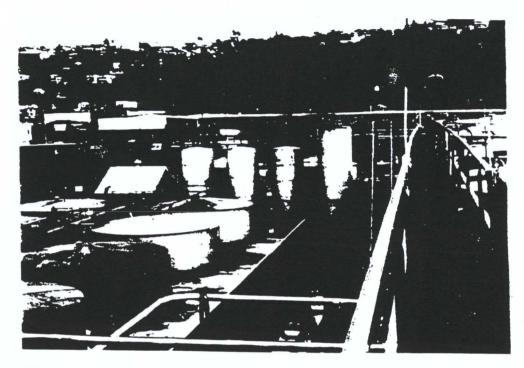
The tanks are fully contained within the Small Yard by a 5-ft retaining wall. The entire area is paved with concrete (since 1986, see Photos 23 and 24). Surface drainage is to the blind sumps within the containment area.

Photo 23. Waste coolant storage tanks.

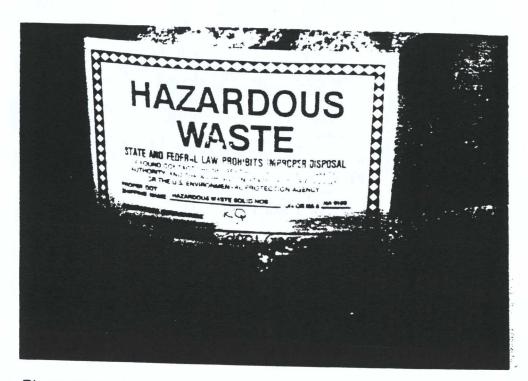
Photo 29. Label on hazardous waste drum.

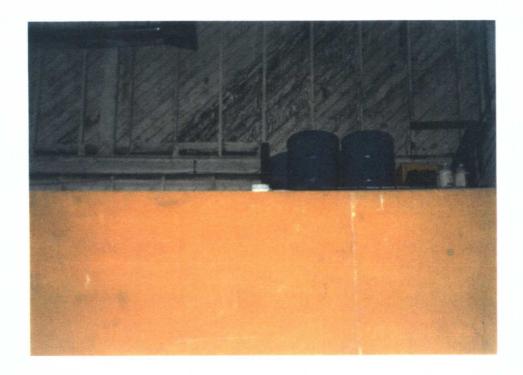
Photograph: 32 Date: October 21, 1992 Taken By: Noushin Arab

Description: Paint buckets near ceiling of building W-47 (SWMU 36)

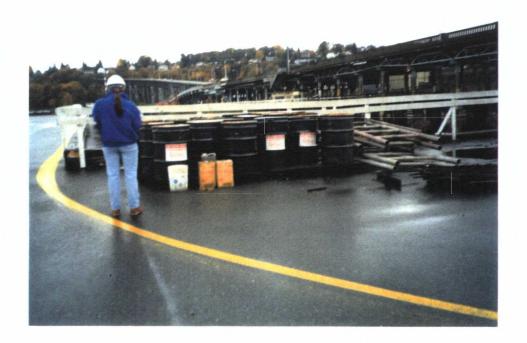
Photograph: 39 Date: October 20, 1992 Taken By: Noushin Arab

Description: 55-gallon drum with unknown content under the freeway (SWMU41)
